Property Address: 1228 Apollo Circle Report ID: 1051

PROPERTY INSPECTION REPORT

Prepared For:	Steve Baker						
	(Name of Client)						
Concerning:	1228 Apollo Circle, Round Rock, TX 78664						
_	(Address or Other Identification of Inspec	cted Property)					
By:	James Sullivan #9789	6/17/08					
-	(Name and License Number of Inspector)	(Date)					
	(Name, License Number and Signature of Sponsoring Inspe	ctor. if required)

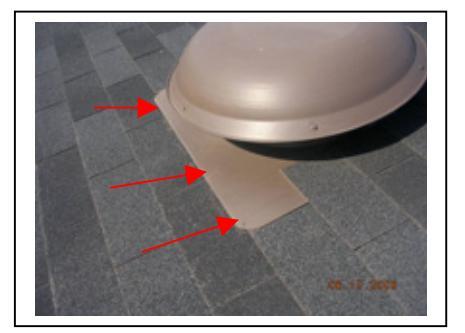
The shingles are in good condition at the time of this inspection. Approximate age is 3 years based on the age of the home. Asphalt Composite shingles have a life expectancy of 15-30 years.

There were exposed nail heads on the vent flashing, roof jacks and cap shingles. Water can leak in around the nail holes, resulting in damage to the structure below. These need to be sealed (roofing caulk).

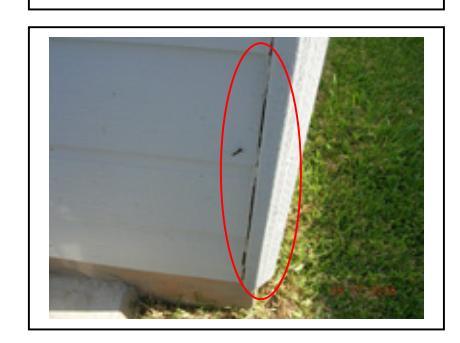
I NI NP R	Inspection Item
	INTERIOR WALLS
3	Damage to the interior finish was observed in many rooms, the most obvious in the hallway off the garage man door. This condition is considered cosmetic, not structural. Recommend repairs.
	BATHROOM WALLS
	The towel rod located in the 2 nd bathroom on the wall is loose. Recommend repairs.
	EXTERIOR WALLS
and the second second	Siding Consist of: ଔBrick Veneer ଔFiber Cement (Hardiplank) ÜVinyl □Composition wood □Wood □Stucco □EIFS □Rock
	Type of Wall Structure: ଔWood Frame ☐Metal Frame ☐Concrete Block Exterior trim: ☐Wood ☑Fiber Cement ☐Covered with Vinyl/Aluminum
	Caulking improvements are recommended in the following areas to help prevent pest infiltration and possible water damage:

- Around all the windows.
- Expansion joint on right side of house
- Around exterior door trim/glazing.
- Wood trim/ends of siding.
- □ Wood and brick/rock intersection.

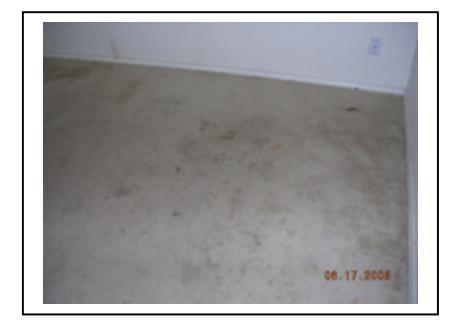
Damage to the interior finish was observed in some of the rooms. This condition is considered cosmetic, not structural. Recommend repairs.

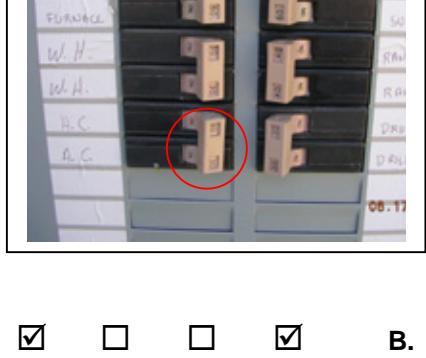
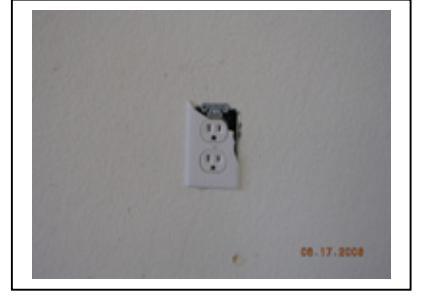
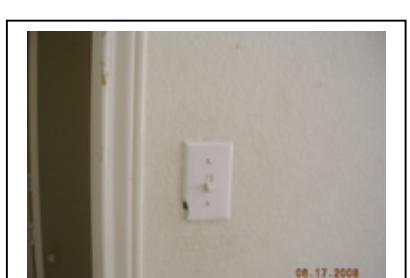
One outlet has a broken cover plate (living area). This condition is unsafe as wires are exposed, creating a shock hazard. Recommend replacing cover plate. One switch had a broken cover plate (bedroom). This condition is unsafe as wires are exposed, creating a shock hazard. Recommend replacing cover plate.

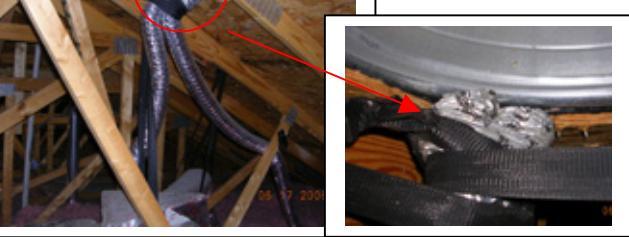
E.	Microwave Cooking Equipment Note: Portable units are not inspected. Comments:
				F.	Trash Compactor Comments:
				G.	Bathroom Exhaust Fans and/or Heaters Comments: The bathroom exhaust fan (front bath and laundry) should be repaired so as to discharge to the building exterior. They are at the vent but routed into the roof decking which is blocking them from exhausting properly.
